UNDERWATER BRIDGE INSPECTION REPORT

STRUCTURE NO. 74539
WEST BRIDGE STREET
OVER THE
STRAIGHT RIVER
DISTRICT 6 - STEELE COUNTY

PREPARED FOR THE
MINNESOTA DEPARTMENT OF TRANSPORTATION
BY
COLLINS ENGINEERS, INC.
JOB NO.5221

MINNESOTA DEPARTMENT OF TRANSPORTATION
UNDERWATER BRIDGE INSPECTION

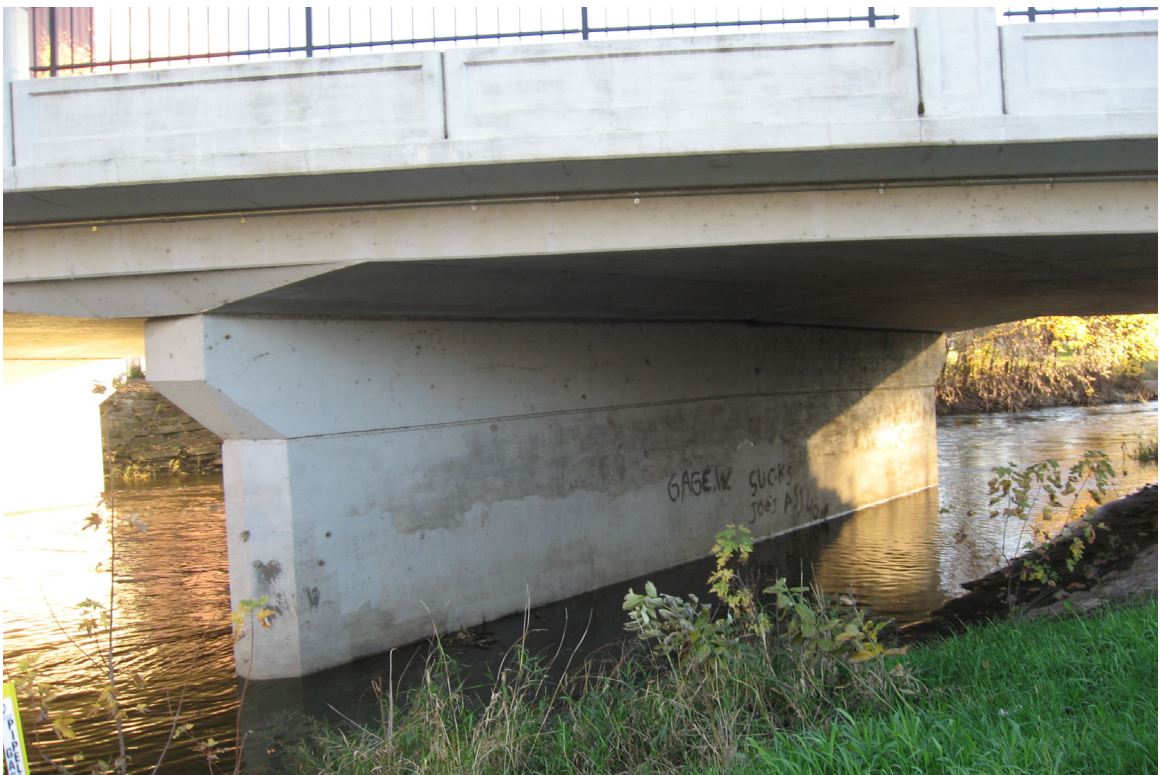
Photograph 2. View of Pier 1, Looking Southeast.

- (A) The concrete pier shafts at Piers 1 and 2 exhibited several random hairline to 1/32-inch-wide cracks that typically extended the full height of the shaft.
- (B) The East Abutment breastwall exhibited several random hairline to 1/16-inch-wide cracks that extended the full height of the wall.

- (A) Reinspect the submerged substructure units at the normal maximum recommended (NBIS) interval of five (5) years.

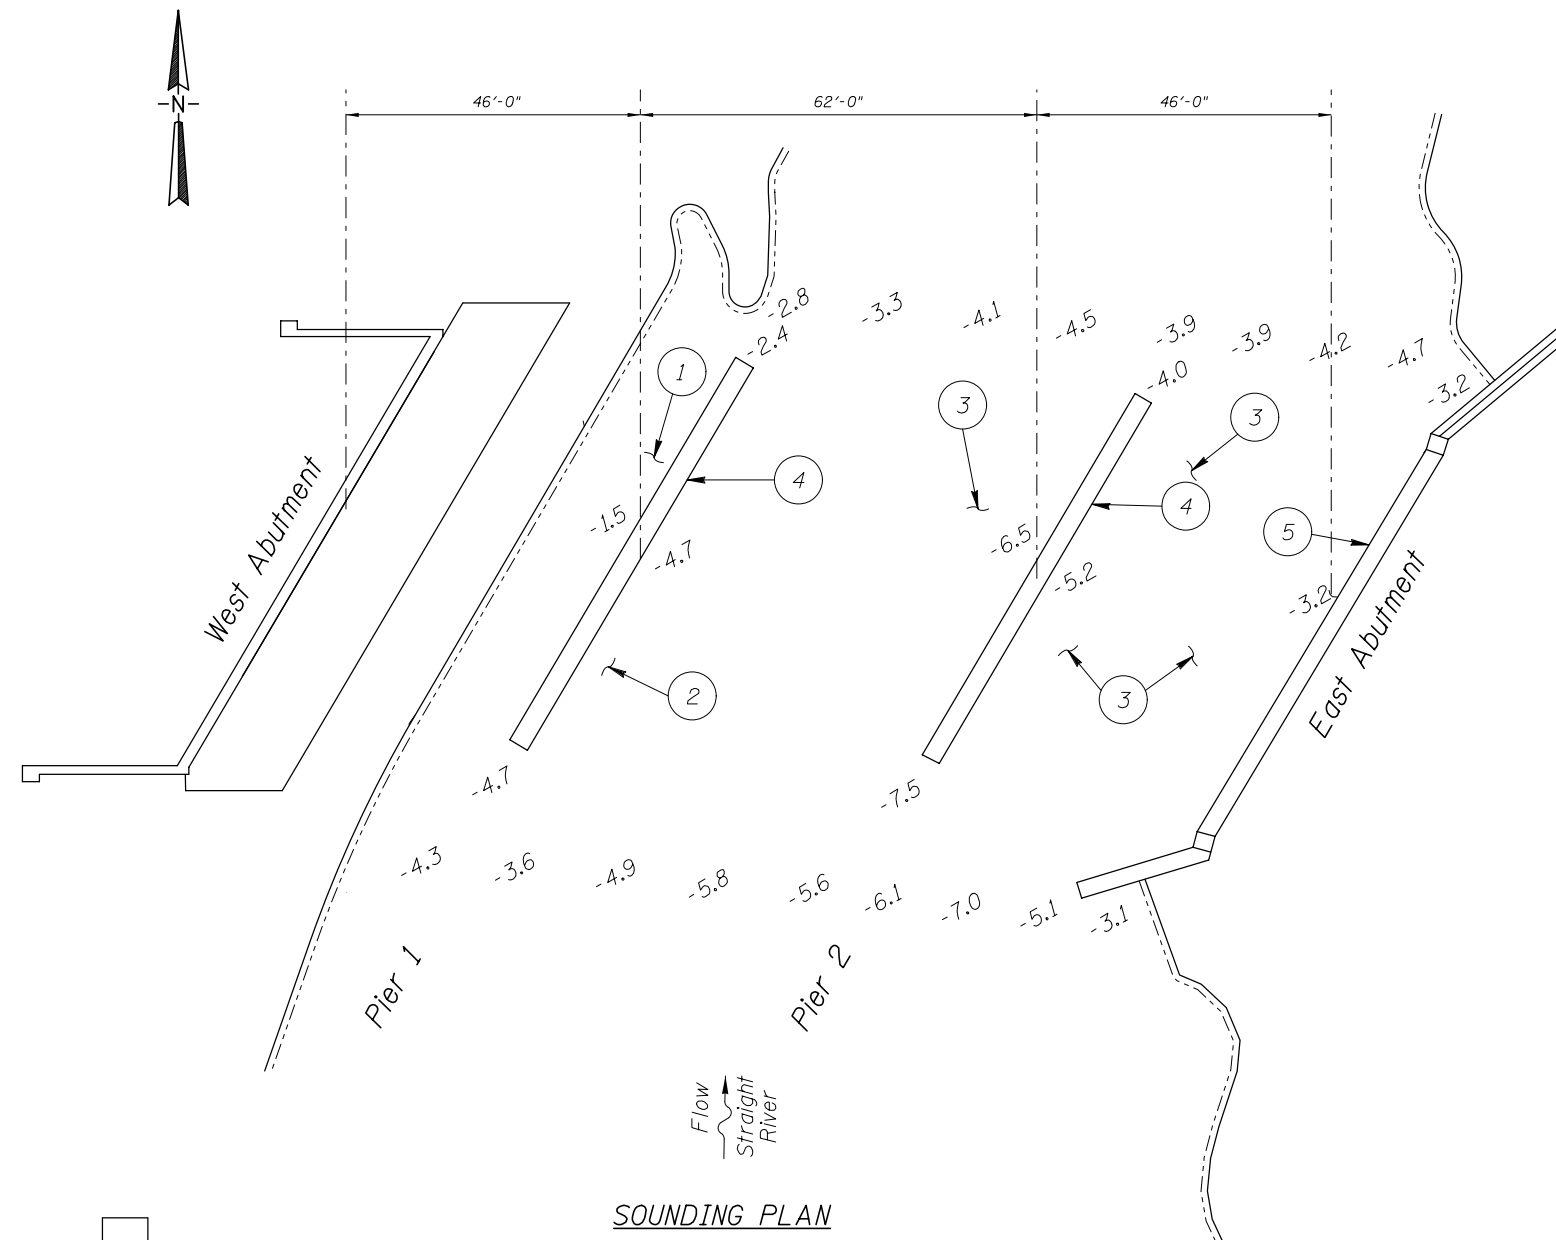
INSPECTION AND SOUNDING PLAN

- 1 The channel bottom consisted of soft silt and organics with up to 2 feet of probe rod penetration.
- 2 The channel bottom consists of silty sand and 2-foot-diameter and smaller rock with up to 3 inches of probe rod penetration.
- 3 The channel bottom consists of 2-foot-diameter and smaller rocks and gravel with soft silt infilling along the eastern side of the downstream nose of Pier 2.
- 4 Random vertical hairline to 1/32-inch-wide cracks were observed along the concrete pier shafts.
- 5 Random vertical hairline to 1/16-inch-wide cracks were observed along the East Abutment breast wall.
